*Ventura Countywide
Stormwater Quality
Management Program*

Ventura Countywide Stormwater Quality
Management Program Annual Report

Attachment E - TMDL Reports Volume II

TOTAL MAXIMUM DAILY LOAD FOR ALGAE, EUTROPHIC CONDITIONS, AND NUTRIENTS IN VENTURA RIVER, INCLUDING THE ESTUARY, AND ITS TRIBUTARIES (VR ALGAE TMDL)

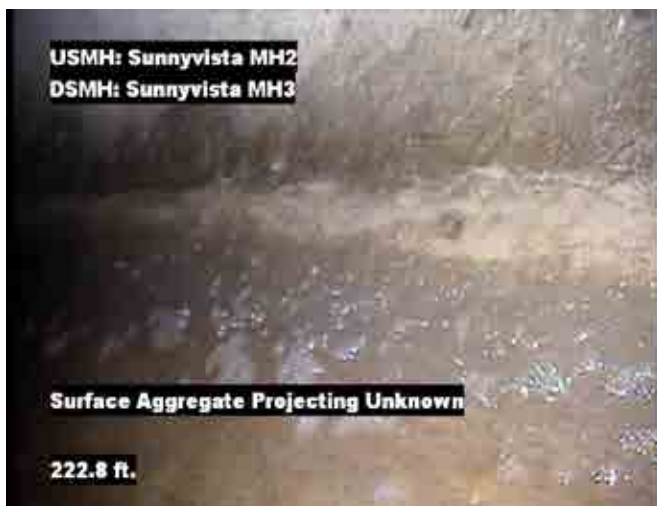
Distance: 222.8 ft. Grade: 3
Condition: Surface Aggregate Projecting Unknown
Remarks: N/A

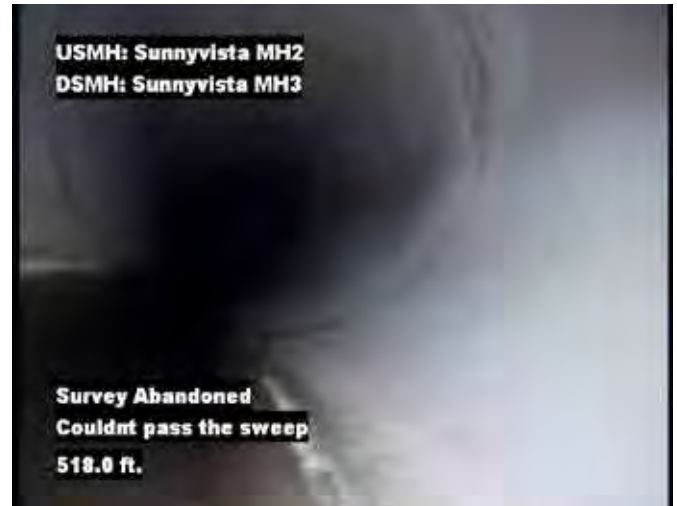
Distance: 518.0 ft. Grade: 0
Condition: Survey Abandoned
Remarks: Couldnt pass the sweep

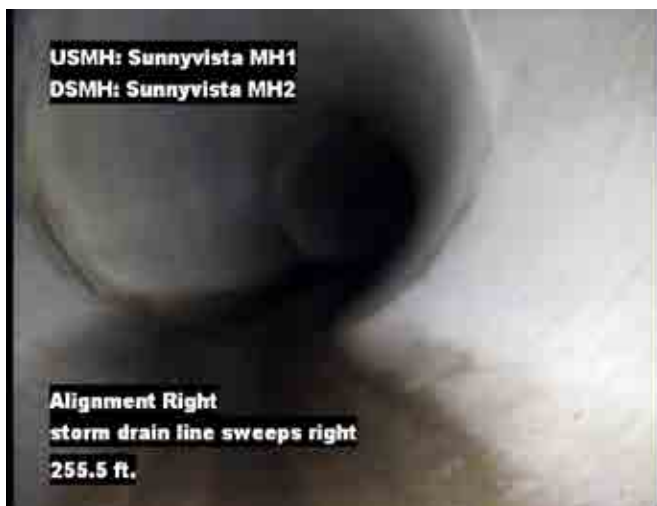
Distance: 255.5 ft. Grade: 1
Condition: Alignment Right
Remarks: storm drain line sweeps right

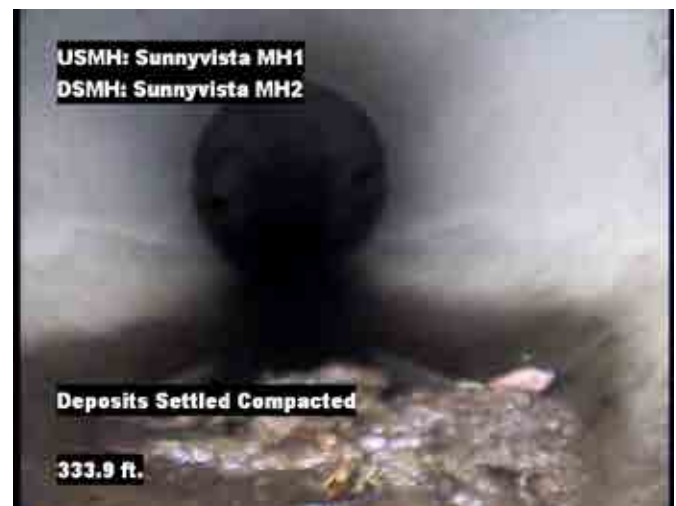
Distance: 333.9 ft. Grade: 3
Condition: Deposits Settled Compacted
Remarks: N/A

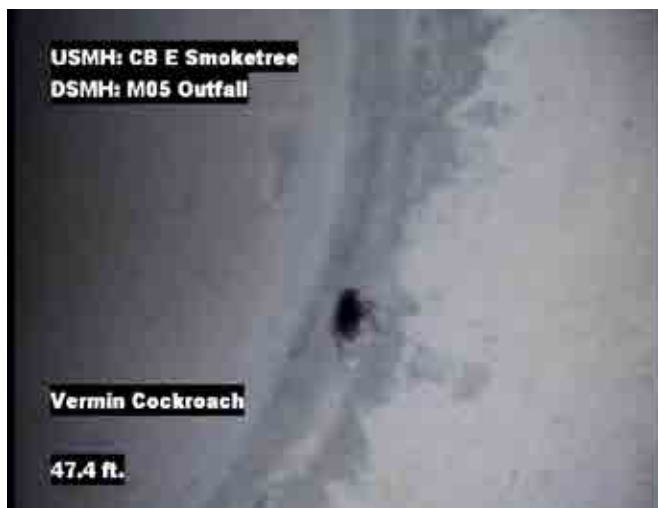
Distance: 47.4 ft. Grade: 1
Condition: Vermin Cockroach
Remarks: N/A

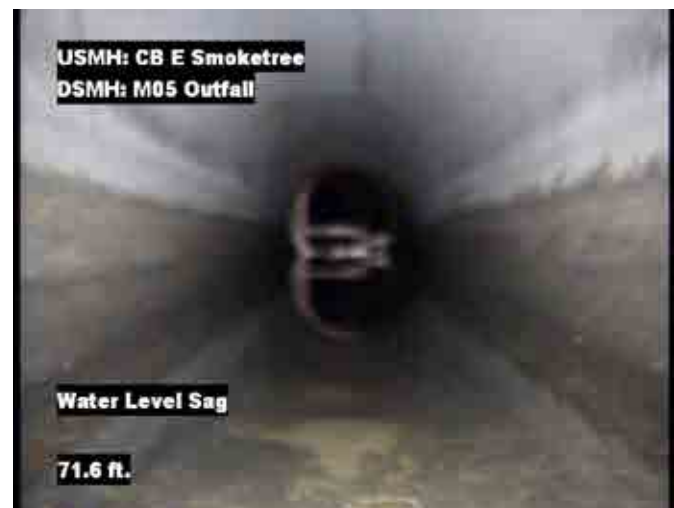
Distance: 71.6 ft. Grade: 2
Condition: Water Level Sag
Remarks: N/A

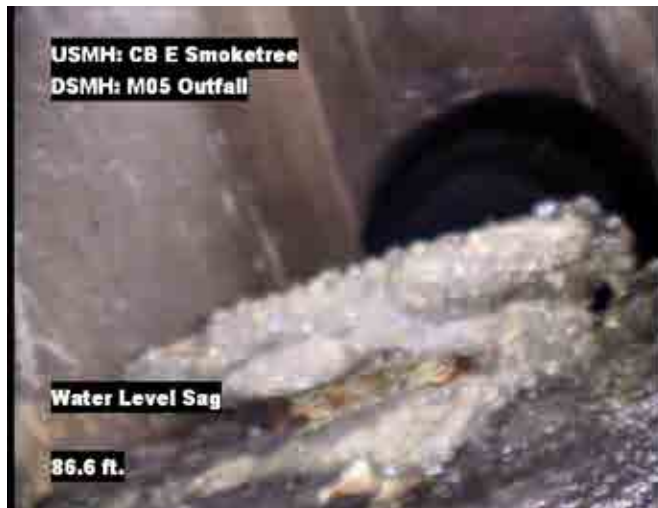
Distance: 86.6 ft. Grade: 2
Condition: Water Level Sag
Remarks: N/A

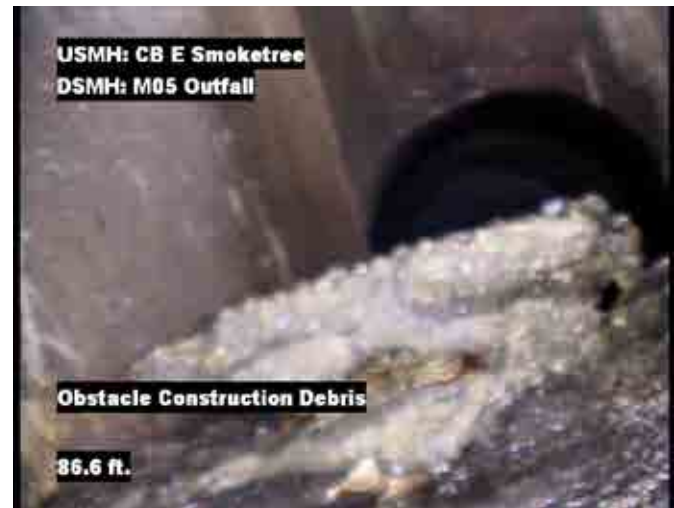
Distance: 86.6 ft. Grade: 5
Condition: Obstacle Construction Debris
Remarks: N/A

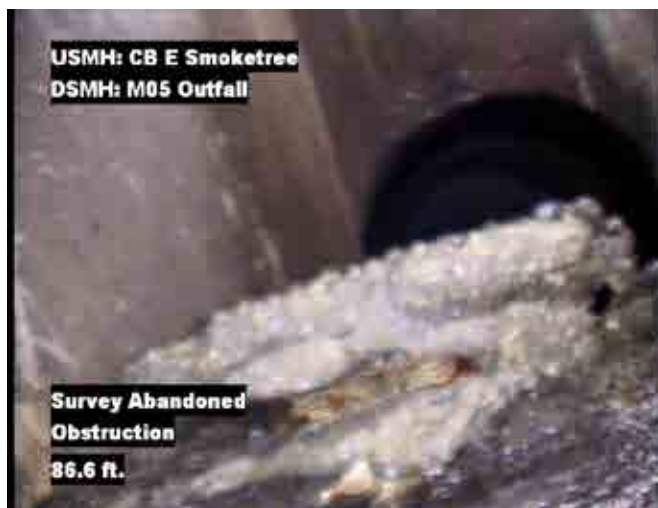
Distance: 86.6 ft. Grade: 0
Condition: Survey Abandoned
Remarks: Obstruction

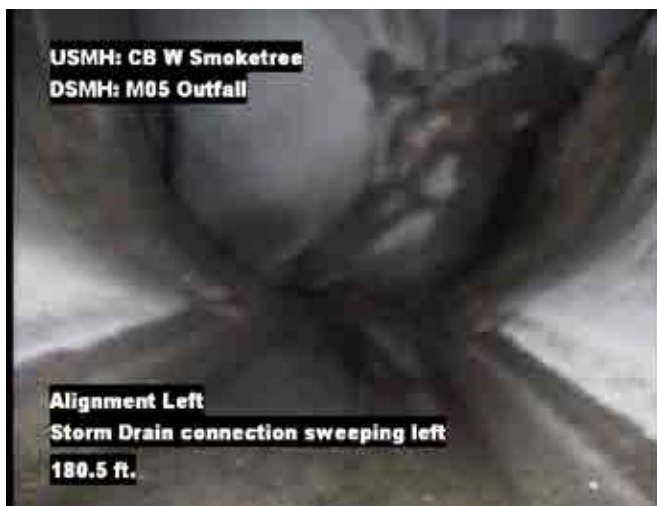
Distance: 180.5 ft. Grade: 4
Condition: Alignment Left
Remarks: Storm Drain connection sweeping left

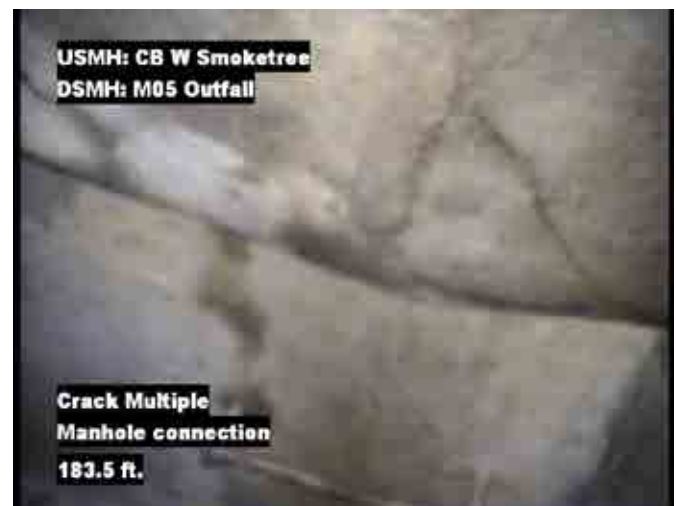
Distance: 183.5 ft. Grade: 3
Condition: Crack Multiple
Remarks: Manhole connection

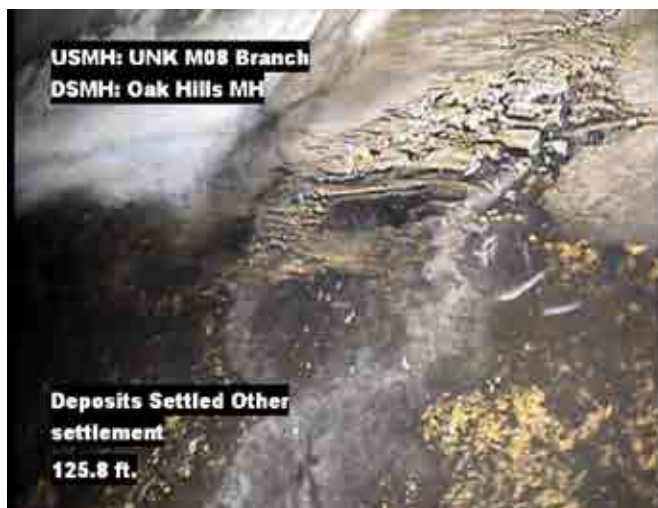
Distance: 125.8 ft. Grade: 2
Condition: Deposits Settled Other
Remarks: settlement

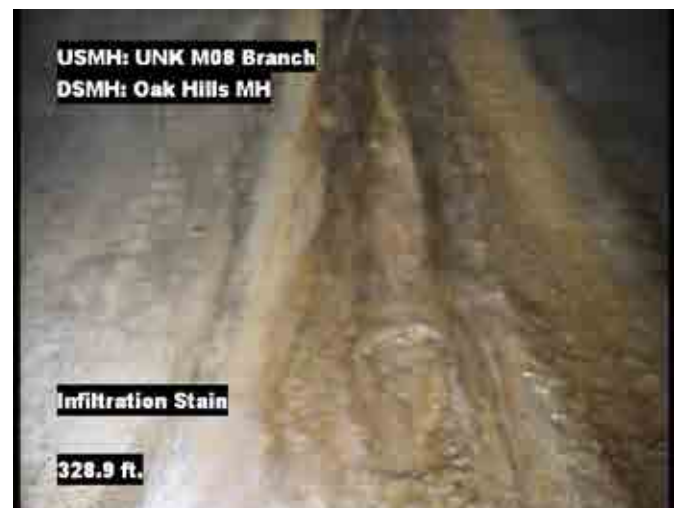
Distance: 328.9 ft. Grade: 0
Condition: Infiltration Stain
Remarks: N/A

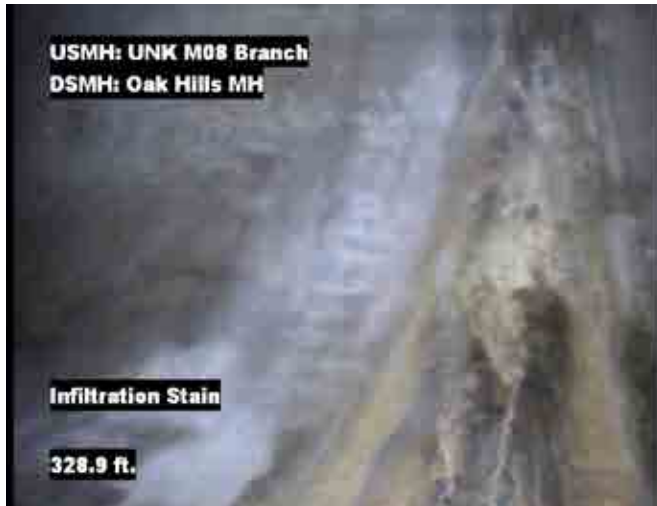
Distance: 328.9 ft. Grade: 0
Condition: Infiltration Stain
Remarks: N/A

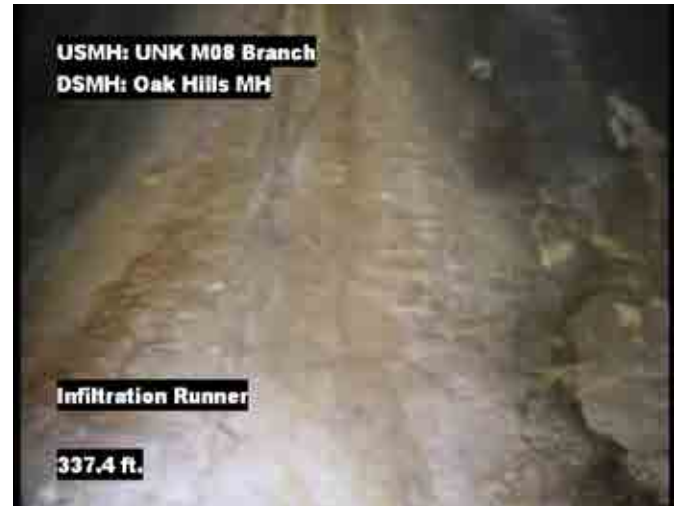
Distance: 337.4 ft. Grade: 4
Condition: Infiltration Runner
Remarks: N/A

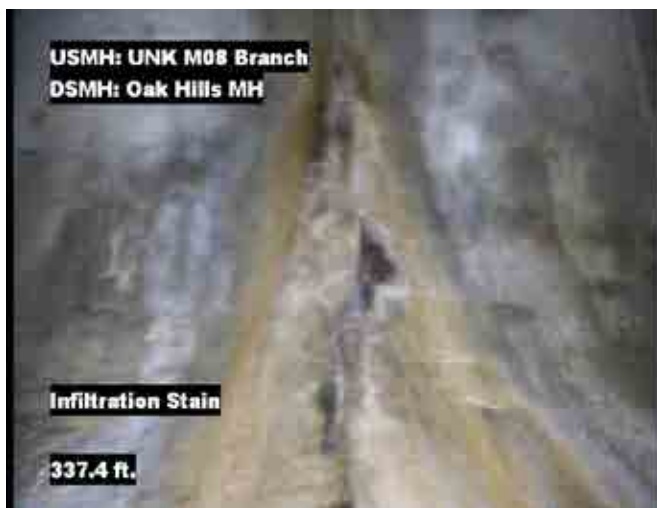
Distance: 337.4 ft. Grade: 0
Condition: Infiltration Stain
Remarks: N/A

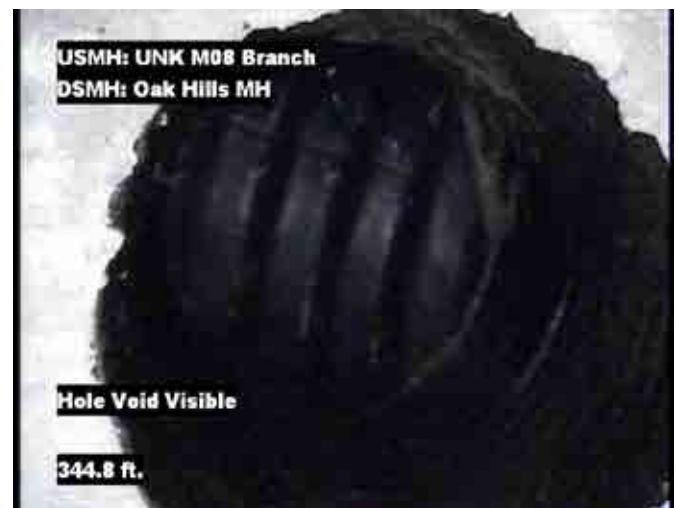
Distance: 344.8 ft. Grade: 5
Condition: Hole Void Visible
Remarks: N/A

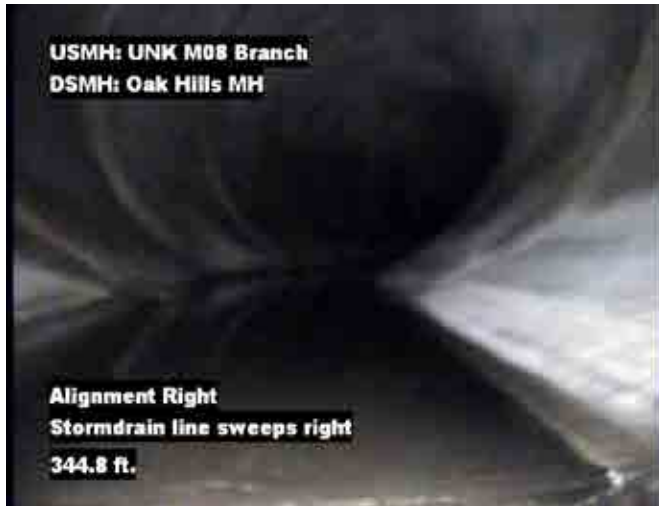
Distance: 344.8 ft. Grade: 2
Condition: Alignment Right
Remarks: Stormdrain line sweeps right
