*Ventura Countywide
Stormwater Quality
Management Program*

Ventura Countywide Stormwater Quality
Management Program Annual Report

Attachment E – TMDL Reports Part 1

City of Thousand Oaks Fiscal Year 2019-20 Annual Trash Report on Compliance with the Malibu Creek Trash TMDL, Resolution R18-006

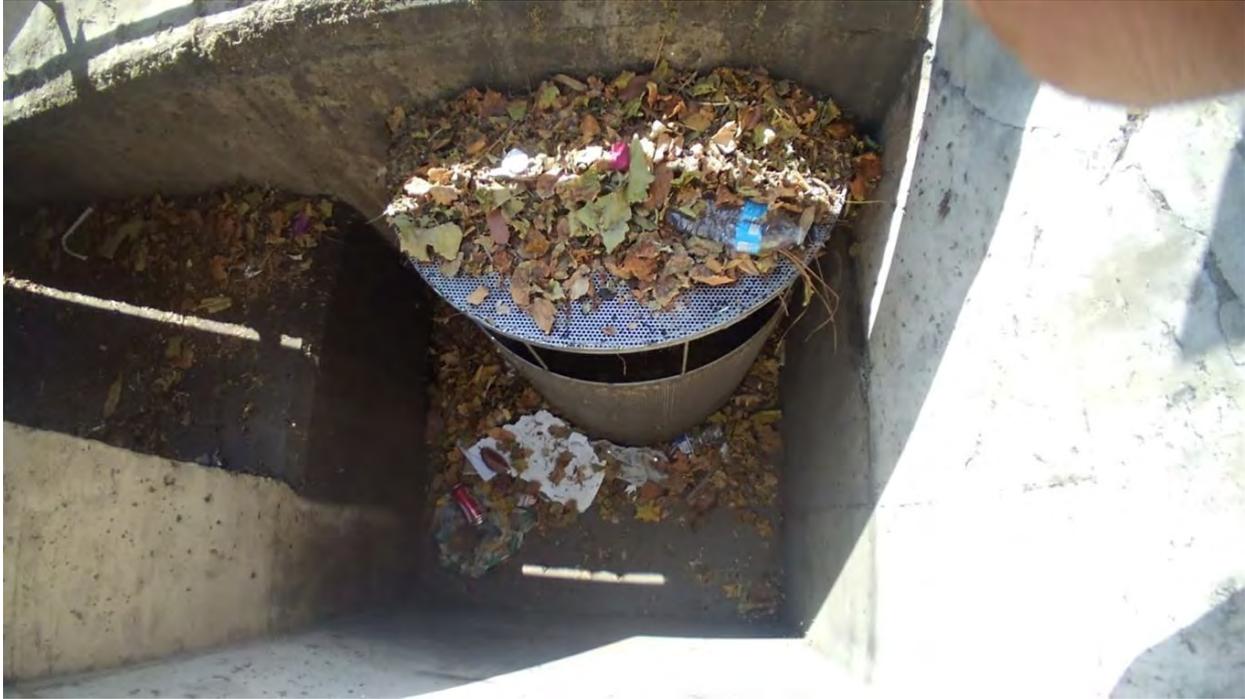
Figure 1: Catch basin prior to cleaning (City of Camarillo catch basin)

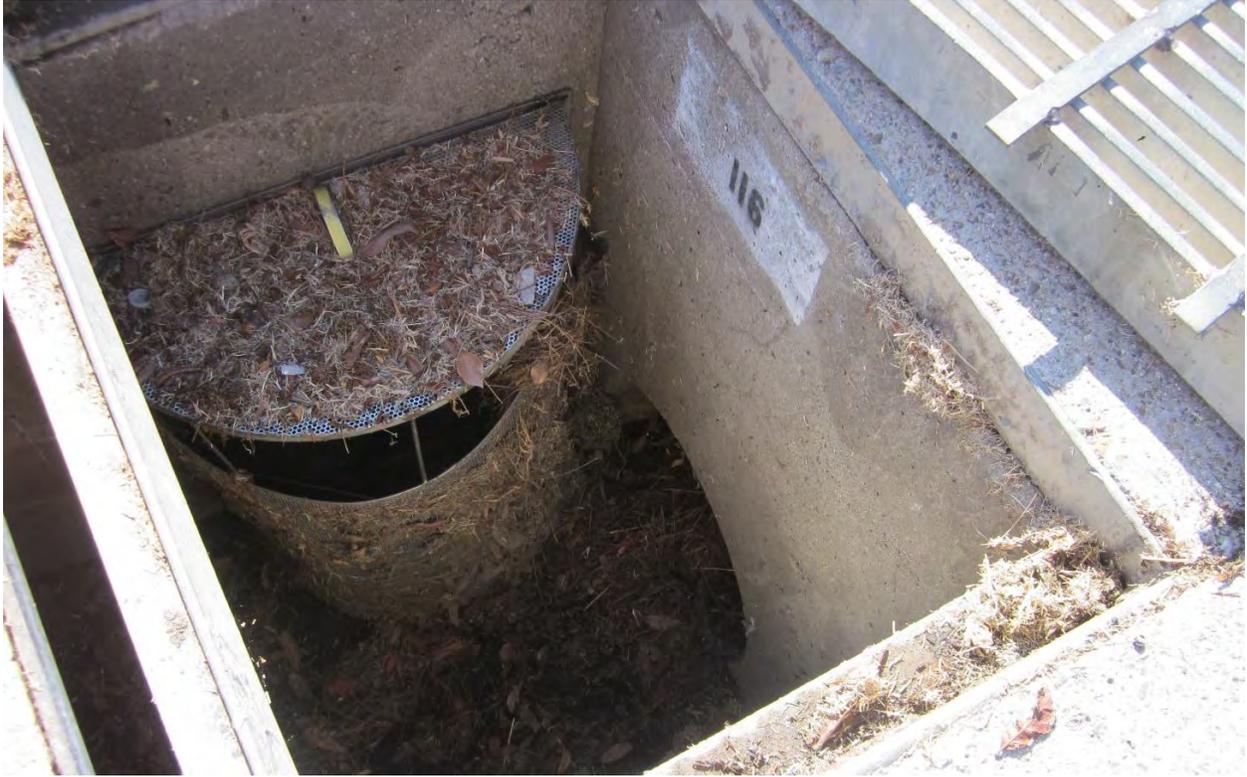
Figure 3: Catch basin prior to cleaning (County of Ventura catch basin)

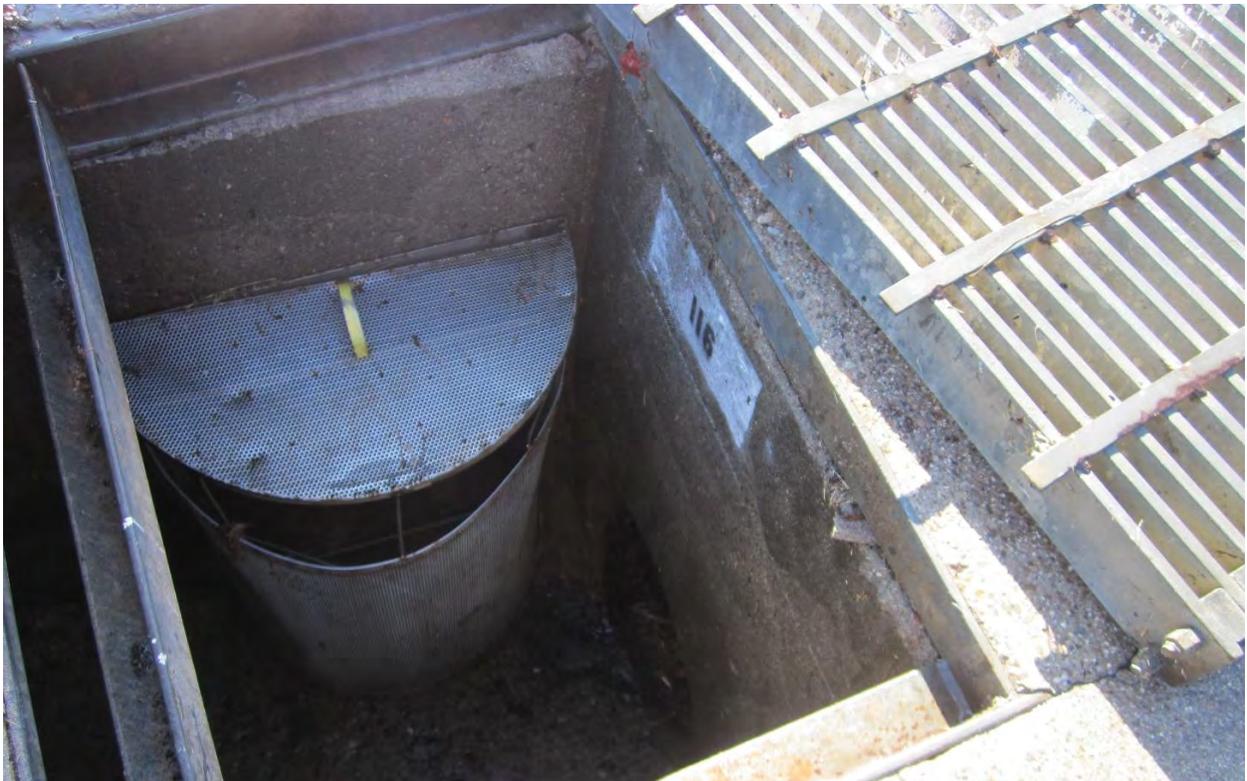
Figure 4: Cleaned catch basin (County of Ventura catch basin)

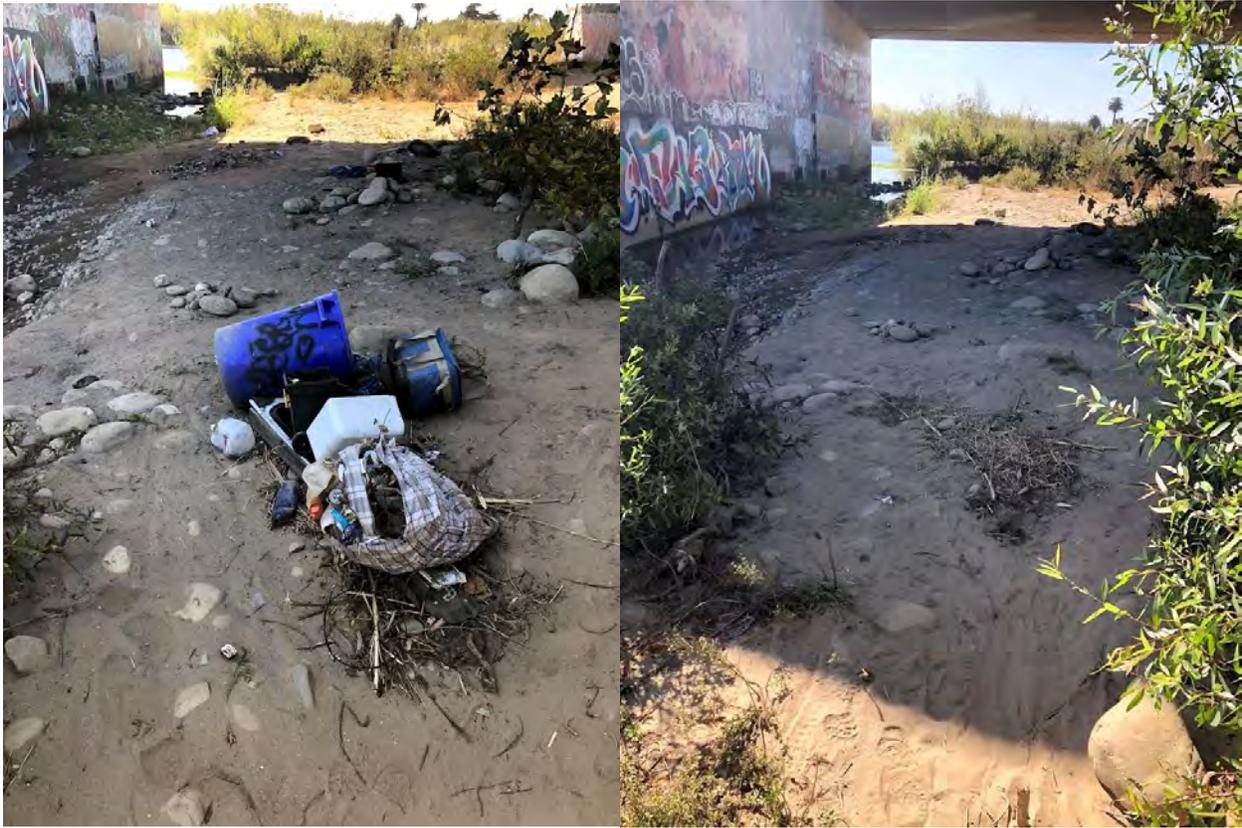
October 11th, 2019: Surveying and cleaning the west side of the Ventura river can be challenging as this area is the farthest from the service road, meaning the trash must be hauled the farthest. Despite the difficulties of cleaning this area, it still requires regular maintenance.

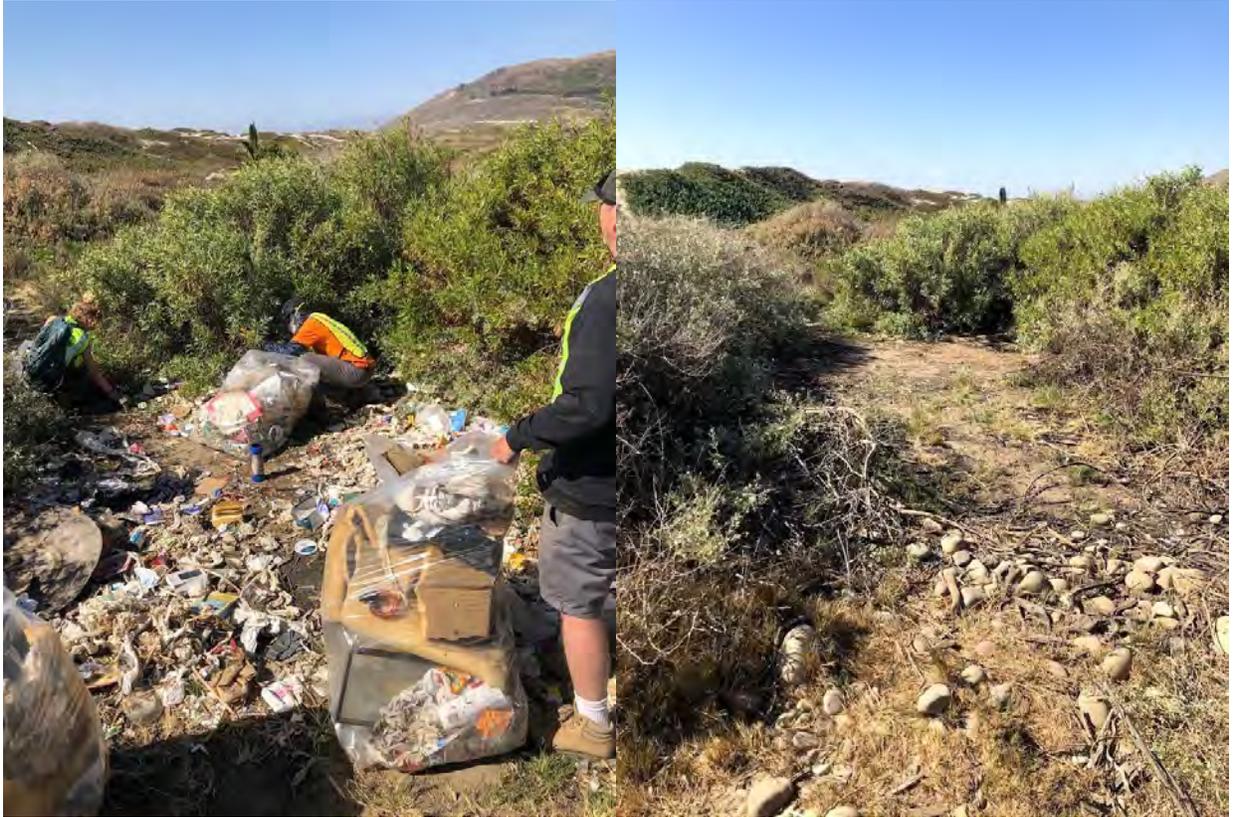
October 30th, 2019: Some of the folks living in the Ventura River collect all of their trash and then choose to dump it in various areas throughout the river, like this area near MFAC area #1. These areas can be jarring when located, and often require the help of volunteers to get cleaned up.

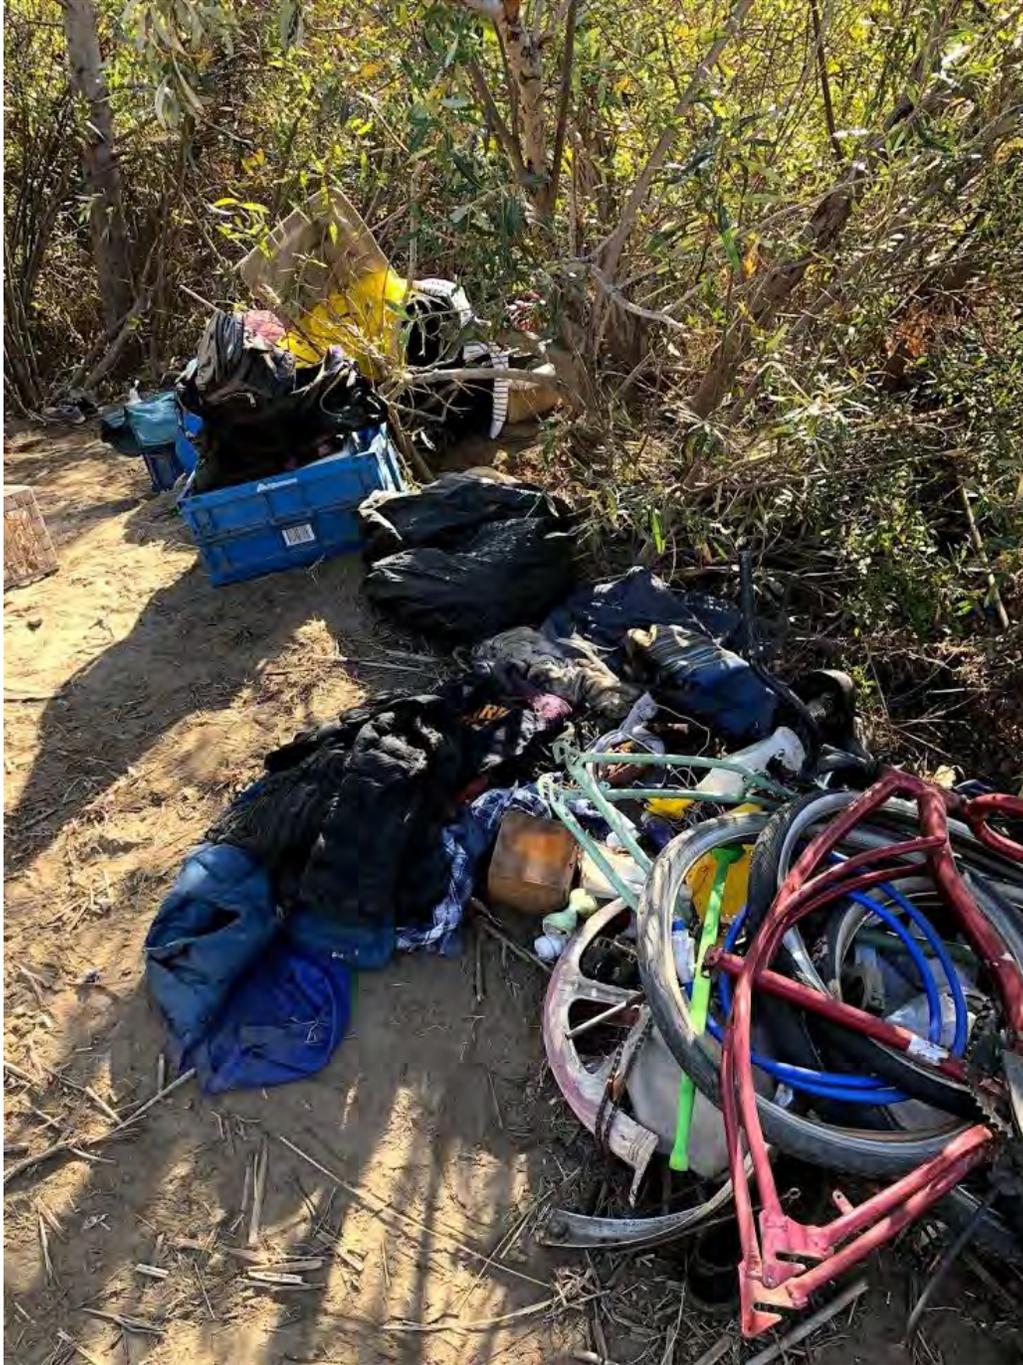
November 26th, 2019: Despite weekly surveys and patrols, certain areas of the Ventura river are prone to collecting trash. The reasons for homeless folks collecting so much trash are varied, but one thing is for certain, it builds up! One of them most popular items in the river are bicycle frames and parts.

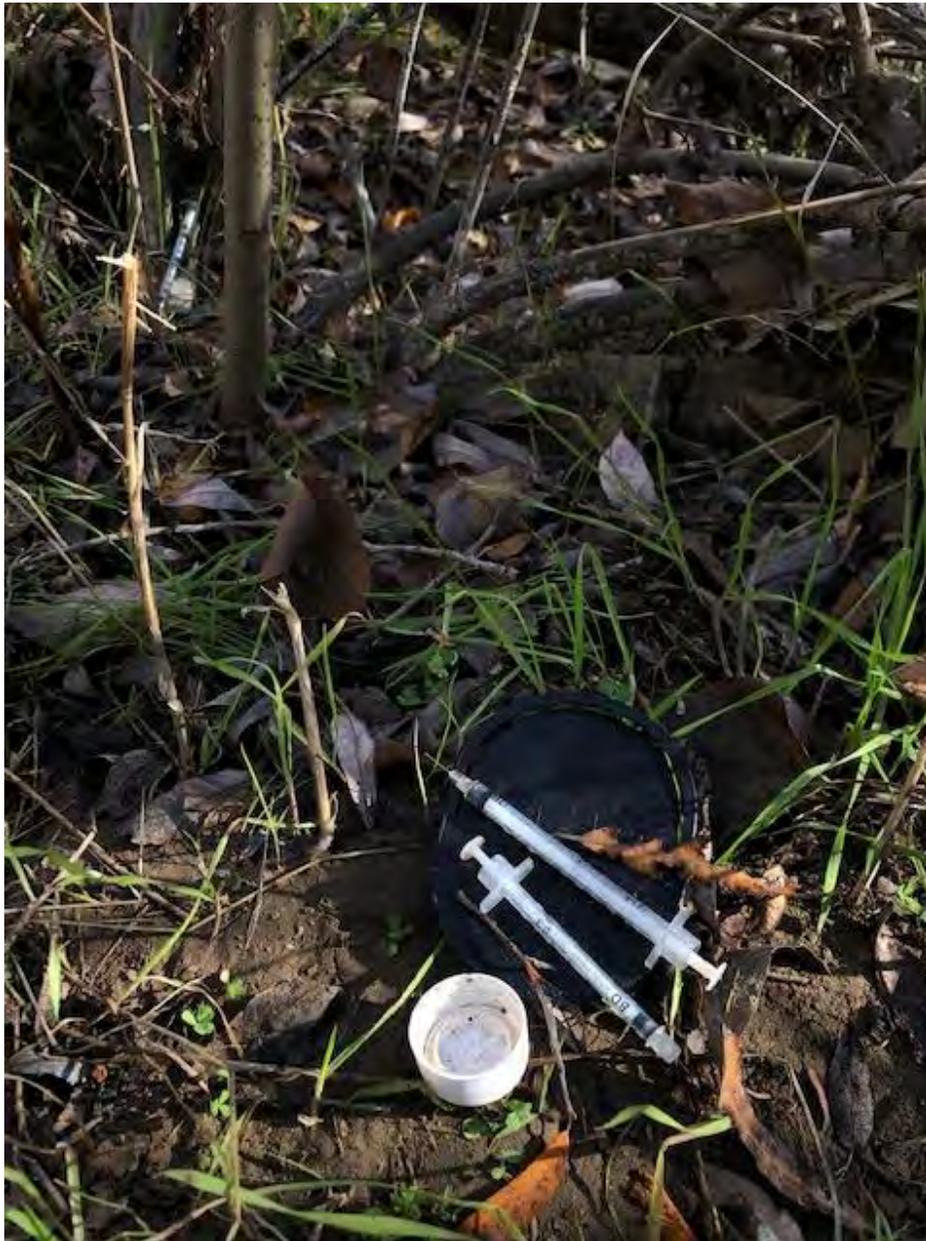
January 13th, 2020: Narcotics use in the Ventura river is common, and VLT staff and volunteers frequently find needles and other drug paraphernalia. In the case of needles, a sharps container is used for disposal in an effort to prevent needle sticks.

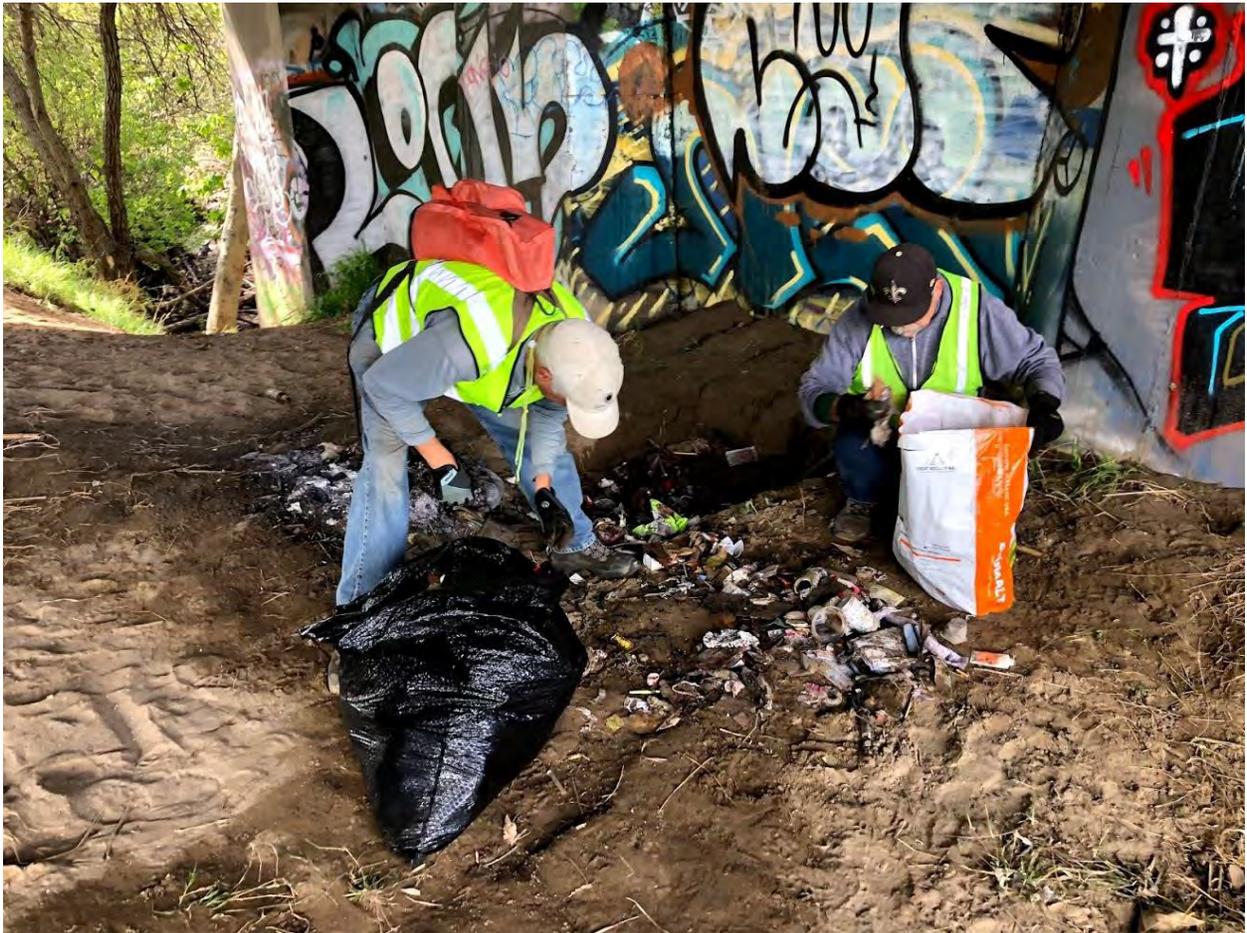
March 17th, 2020: Here Lead Parkway Patroller John Harrison and another volunteer sift through the burnt remains of a trash pile. Often, when asked to move, homeless folks will light their trash and belongings on fire, creating an even more difficult clean up job. Luckily, VLT staff and volunteers are committed to keeping the river clean.

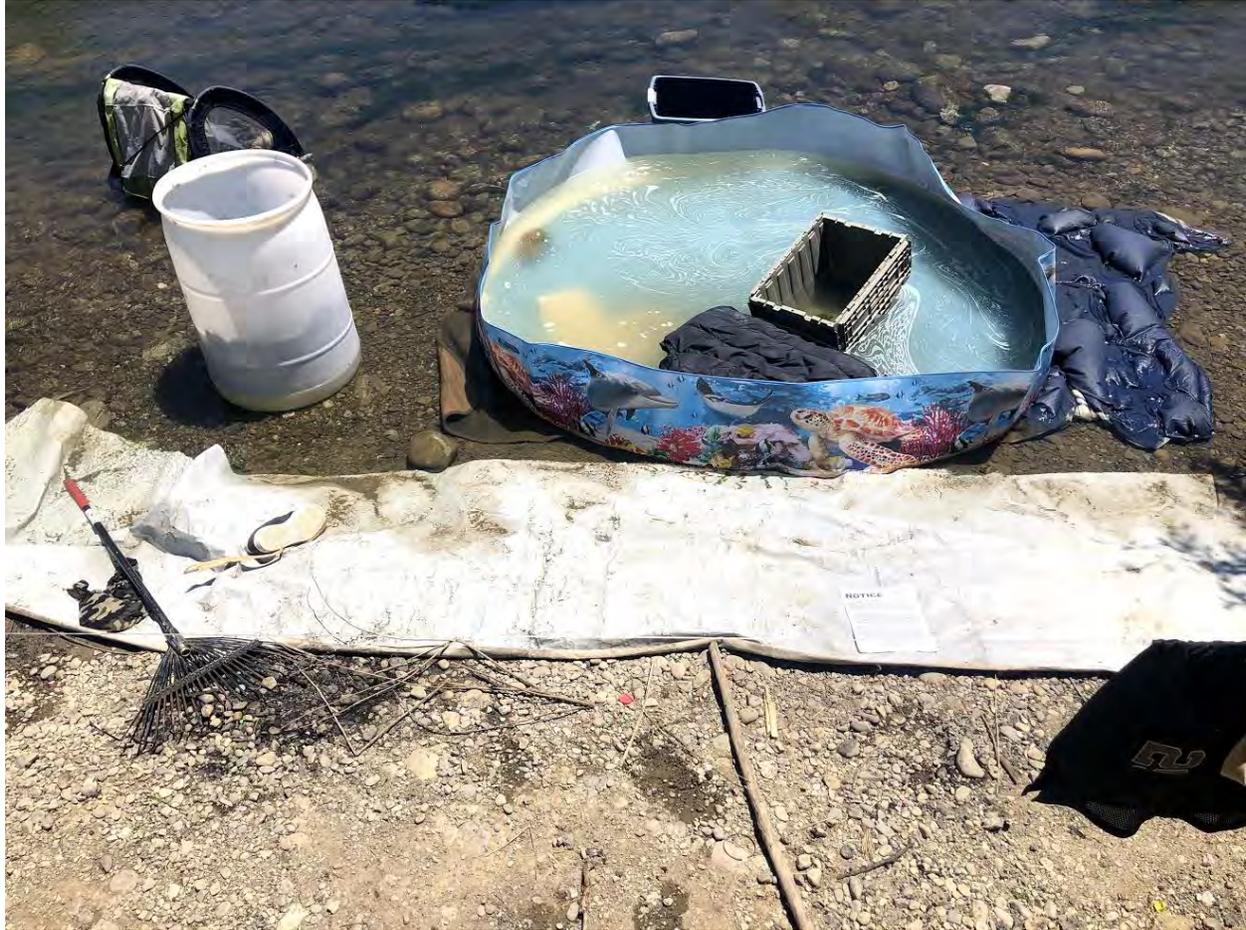
May 20th, 2020: In addition to camps becoming more entrenched during the COVID slowdown, washing spots also became more established. This clothing washing area, utilized by residents of the river bottom, is incredibly destructive to the riparian habitat due to soap discharge and general disturbance of the river channel. VLT staff and volunteers are consistently removing washing stations from the river channel.

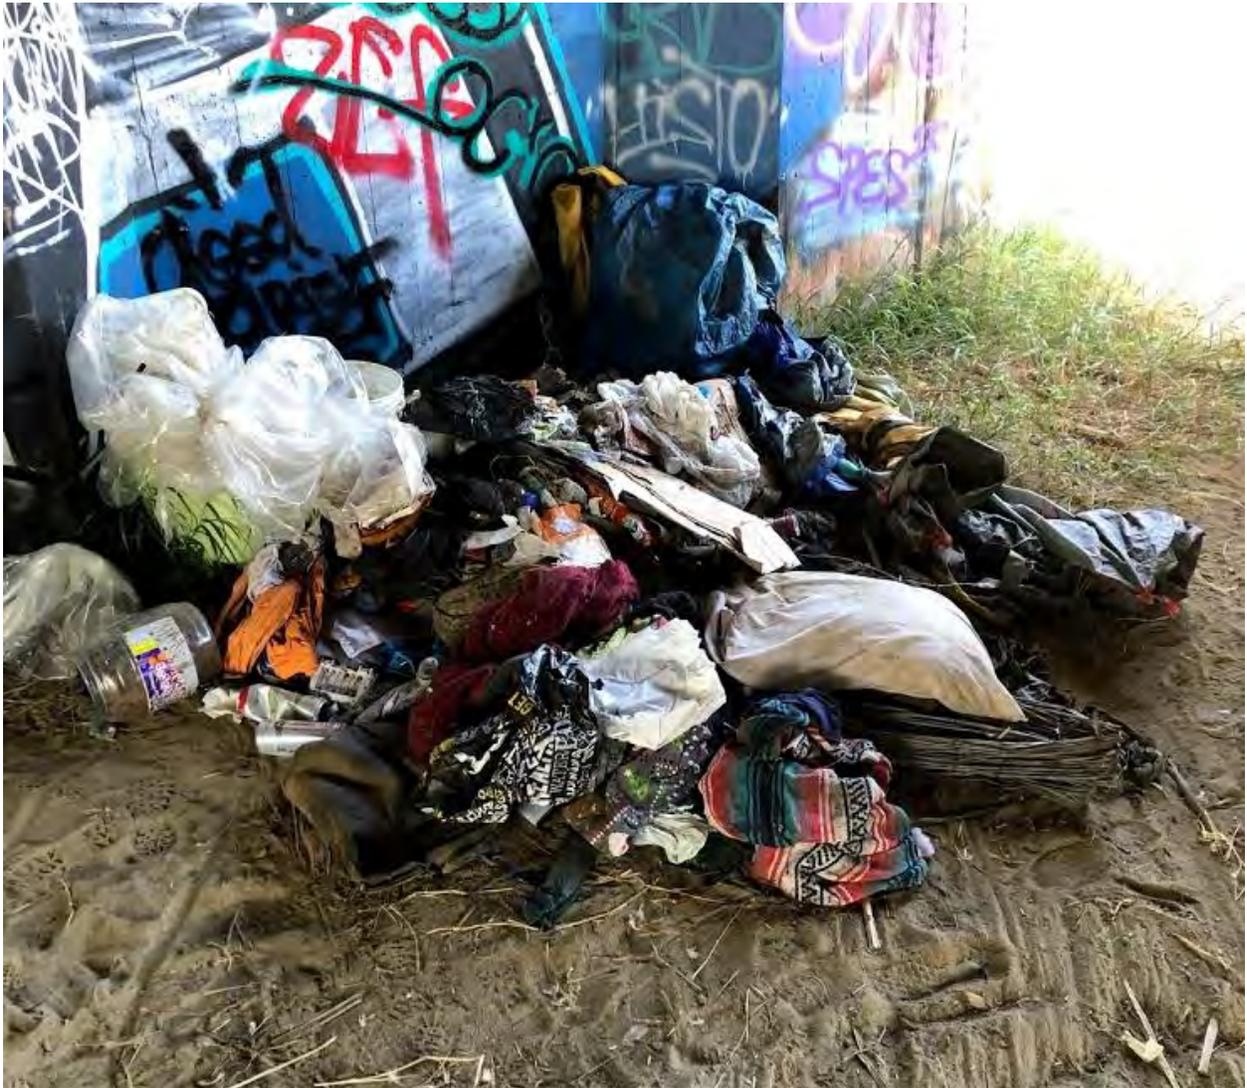
August 6th, 2020: A difficult aspect of trash collection in the Ventura river is that it is very challenging to stage trash for pickup without it being stolen or strewn about. In this photo, you can see a pile of empty trash bags on the left of all the loose trash. Volunteers had spent an hour or so bagging all this trash up, and then moved South through the estuary to continue collecting. Upon returning to the staged trash bags, we found all of our work undone, and trash strewn about.

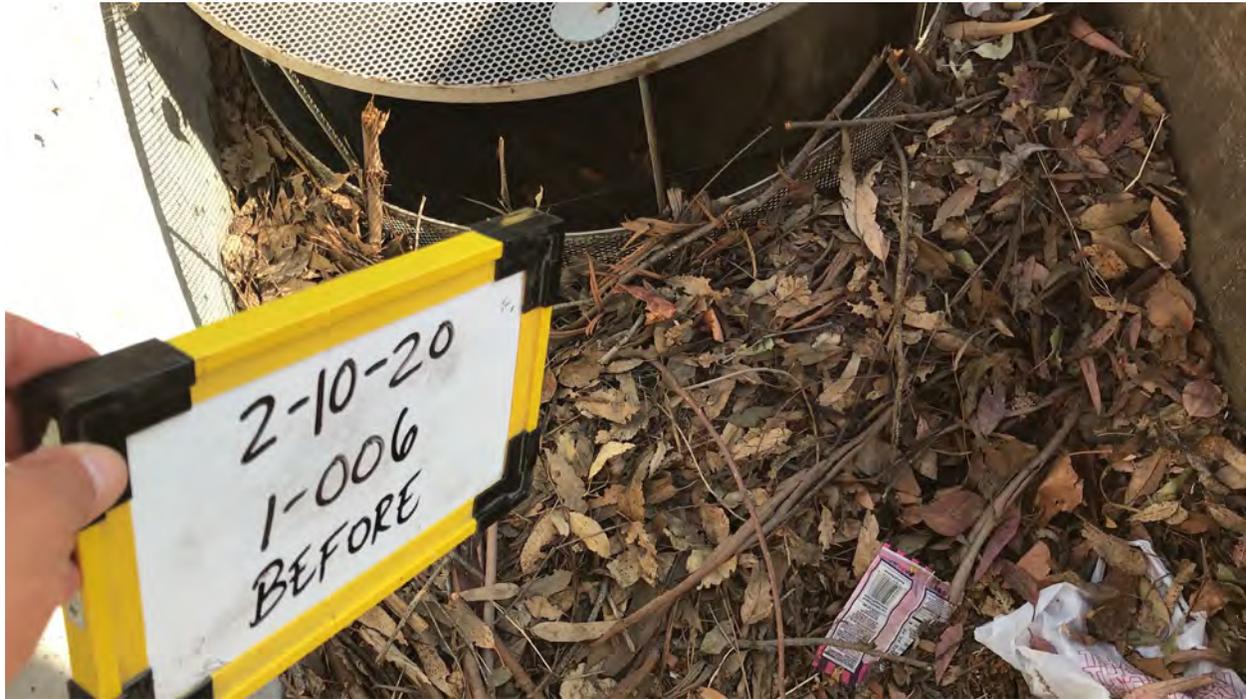
Figure 1: Catch basin prior to cleaning (County of Ventura catch basin)

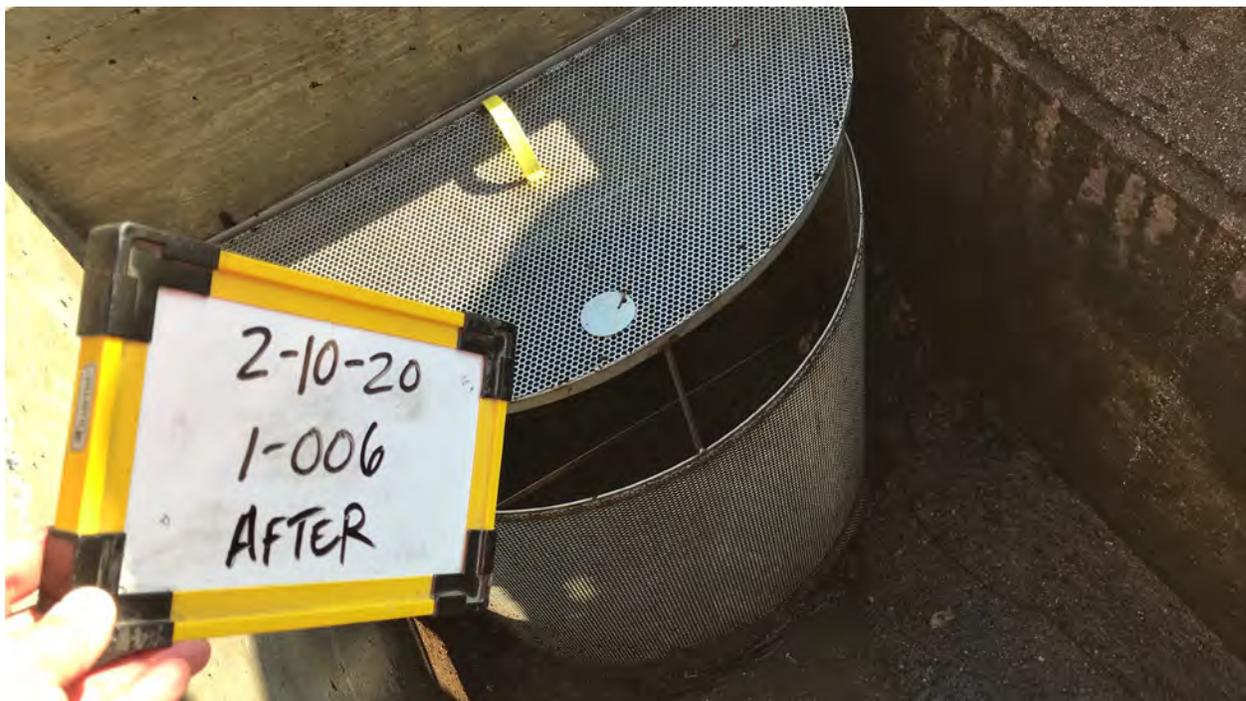
Figure 2: Cleaned catch basin (County of Ventura catch basin)
