*Ventura Countywide
Stormwater Quality
Management Program*

Ventura Countywide Stormwater Quality
Management Program Annual Report

Attachment E - TMDL Reports Volume II

TOTAL MAXIMUM DAILY LOAD FOR ALGAE, EUTROPHIC CONDITIONS, AND NUTRIENTS IN VENTURA RIVER, INCLUDING THE ESTUARY, AND ITS TRIBUTARIES (VR ALGAE TMDL)

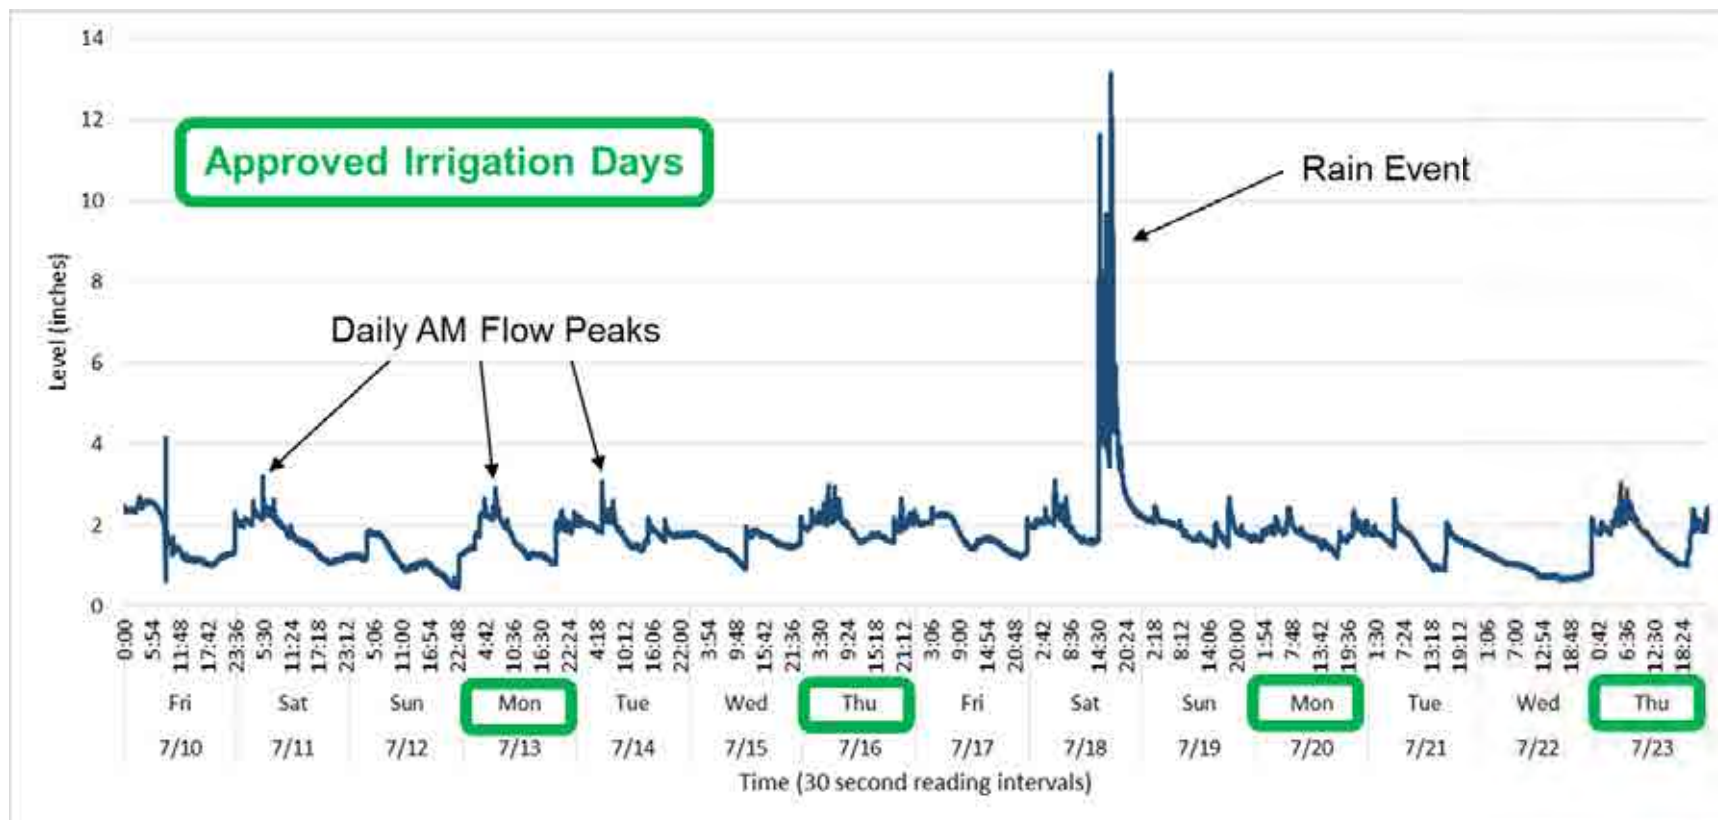
Figure 9. Level logger data plot from outfall M01.

Continuous flow depth monitoring results showed daily flow peaks in nearly all outfalls that were investigated. Although these peaks varied from day to day, a visual analysis of the data provided estimated times for the flow peaks captured in each outfall (Table 6). Only outfalls M06 and M27 did not have clear daily flow peaks recorded by the level loggers. Fluctuations in water level were captured at both dry outfall control locations (M06 and M16), suggesting that intermittent flows may be occurring in outfalls that were not flowing during flow survey and field sampling observations. Daily flow peaks at other outfalls in the Medea Creek subwatershed did not correspond to allowed irrigation days, but were observed almost daily. Daily flow patterns were particularly evident in outfalls M01 (Figure 9) and M17 (Figure E-7). Outfall M16 showed a weekly flow peak each Tuesday (Figure E-6). Flow at Lindero Creek outfall L03 was relatively consistent with a small daily increase during the morning and several larger flow peaks, one of which corresponded to the rain event on 7/18/15 (Figure E-10).

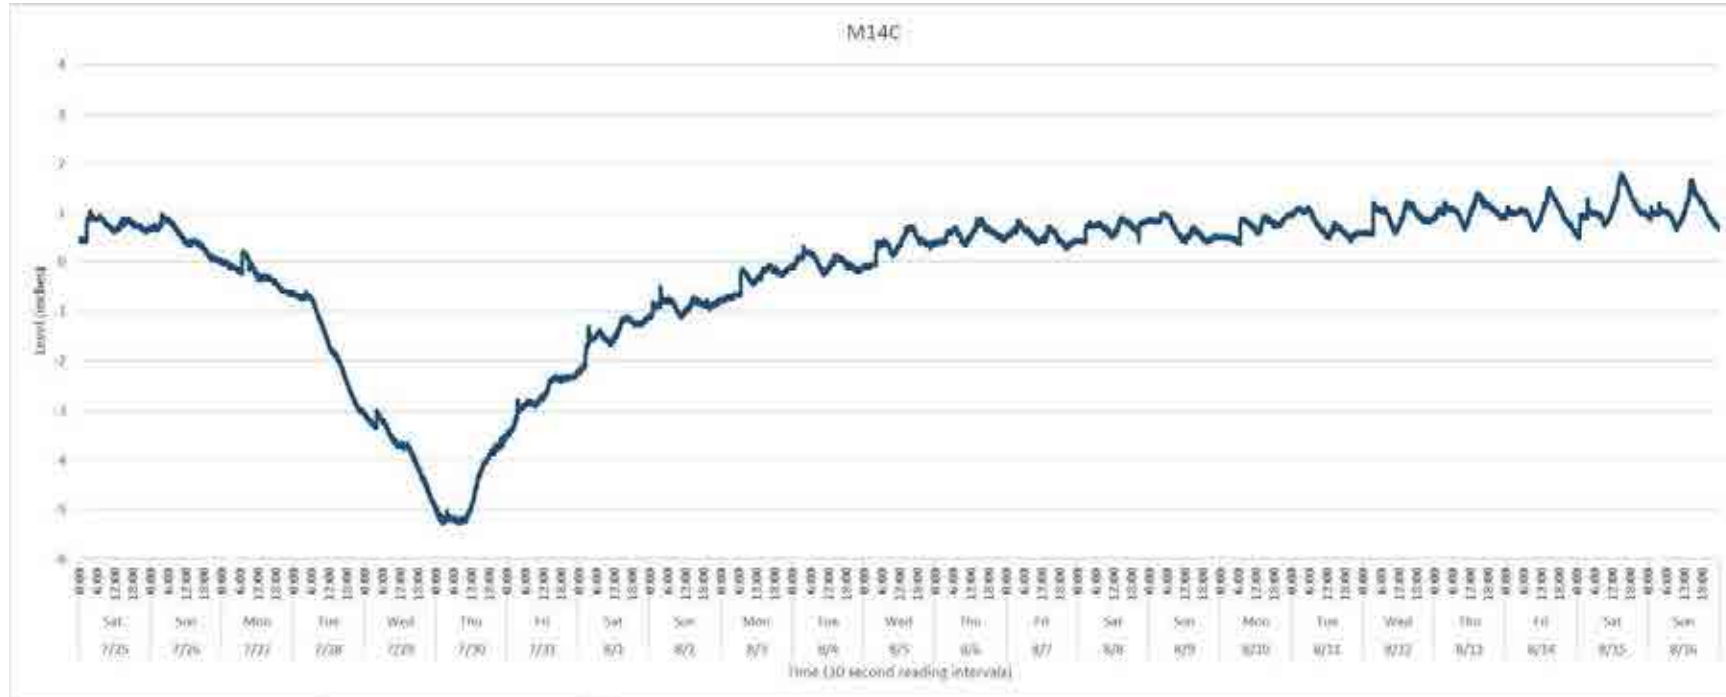
Figure E-5. Level logger data plot for outfall M14C. *Data indicates the level logger malfunctioned during deployment.

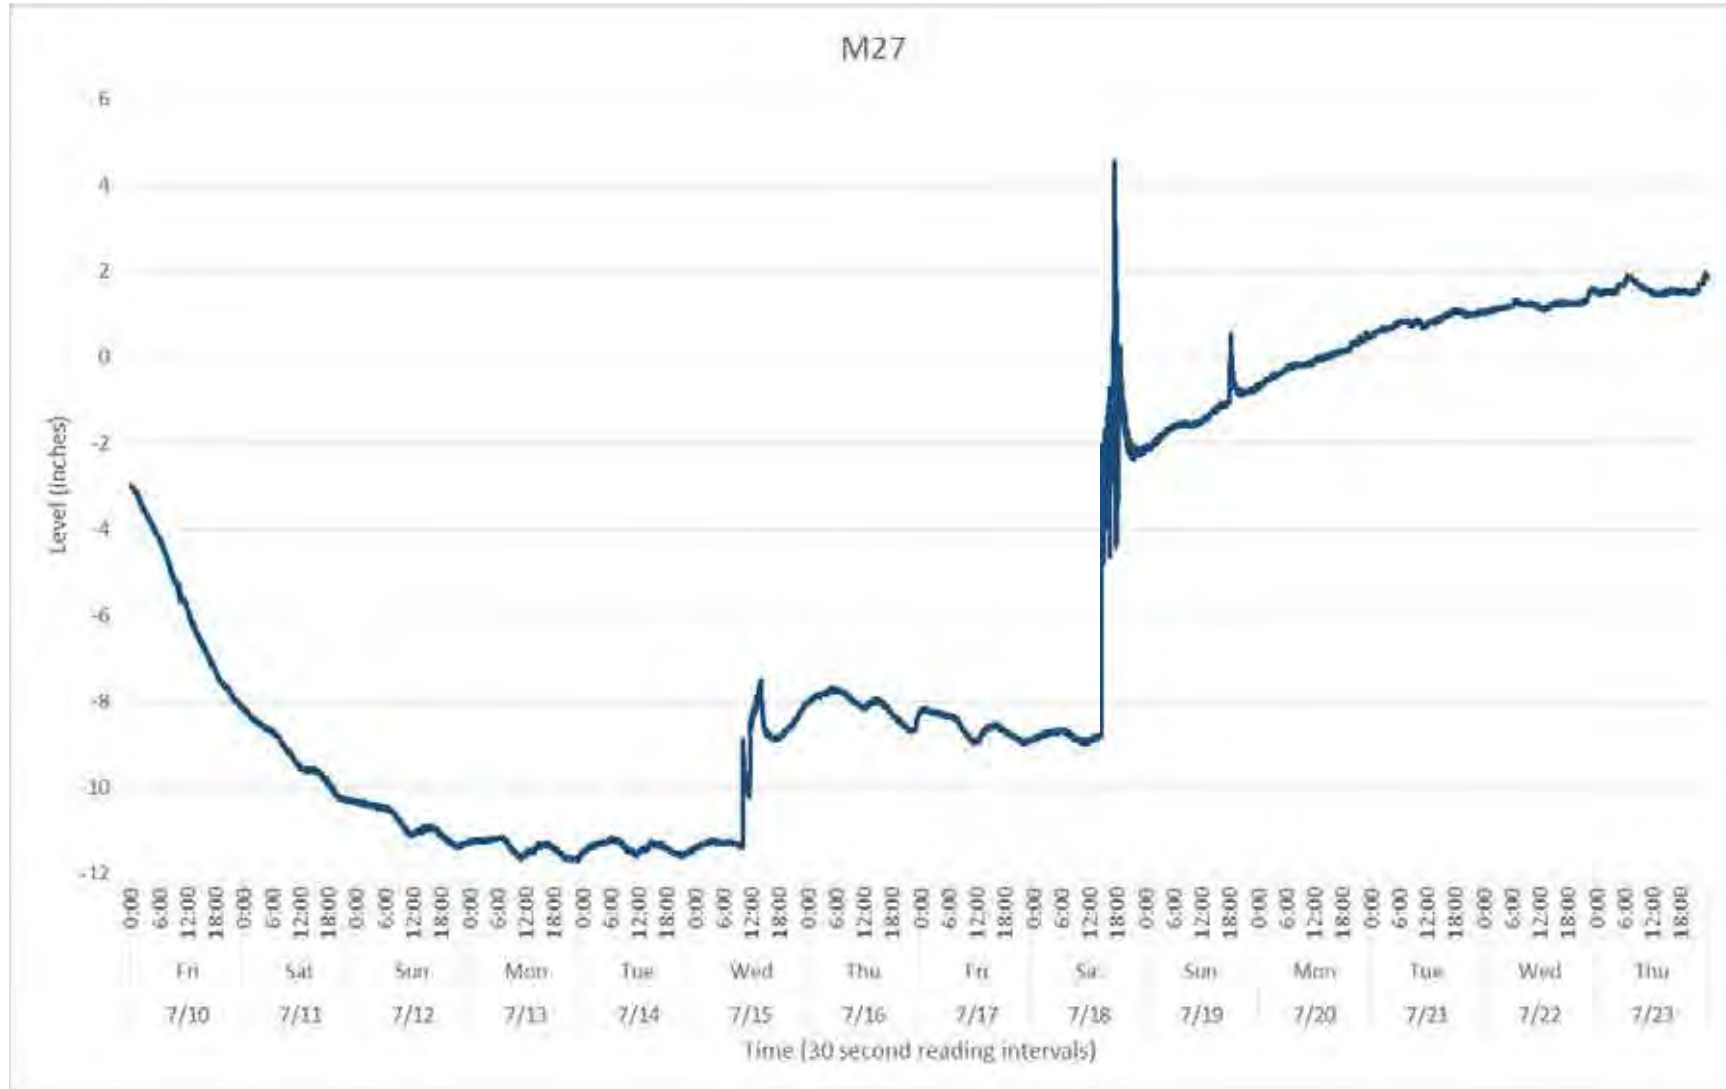
Figure E-8. Level logger data plot for outfall M27. *Data indicates the level logger malfunctioned during deployment.

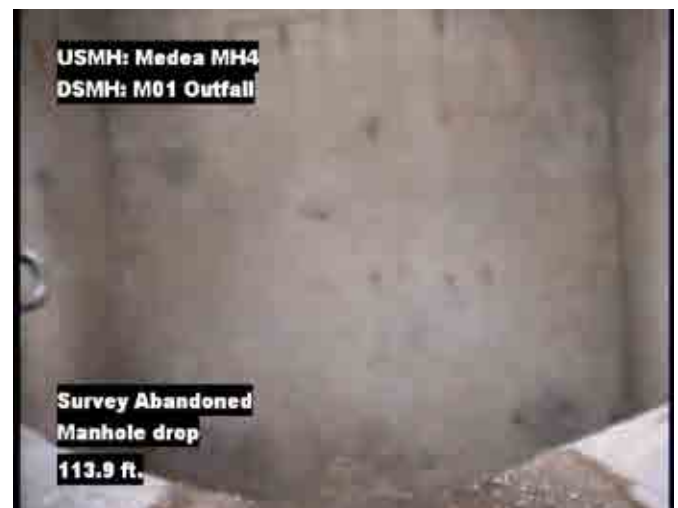
Distance: 113.9 ft. Grade: 0
Condition: Survey Abandoned
Remarks: Manhole drop

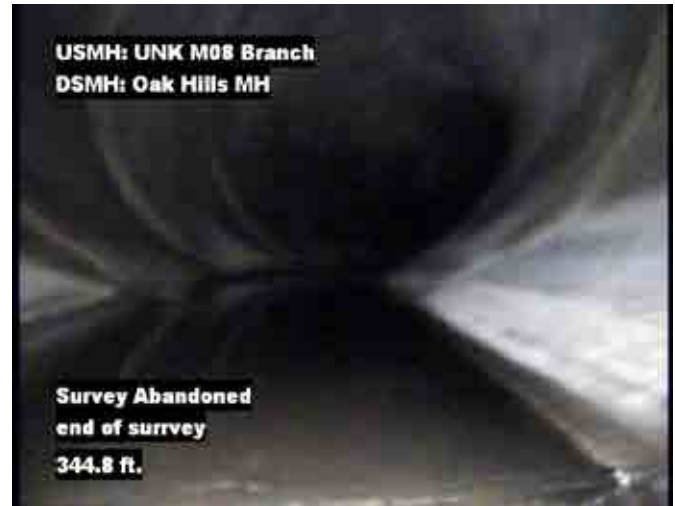
Distance: 344.8 ft. Grade: 0
Condition: Survey Abandoned
Remarks: end of survey
